Application of a Landscape Evolution Model to Gully Management and Reclamation on Military Lands: Fort Carson, CO Case Study

Annual report submitted to the Army Research Office

Daniel B. G. Collins, Gregory E. Tucker¹, Nicole M. Gasparini, and Rafael L. Bras March, 2000

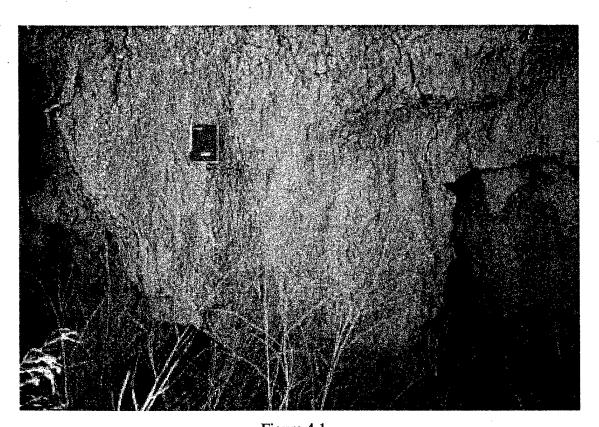
Figure 4.1

Tunnel erosion and cracks on a vertical side wall in PCMS.

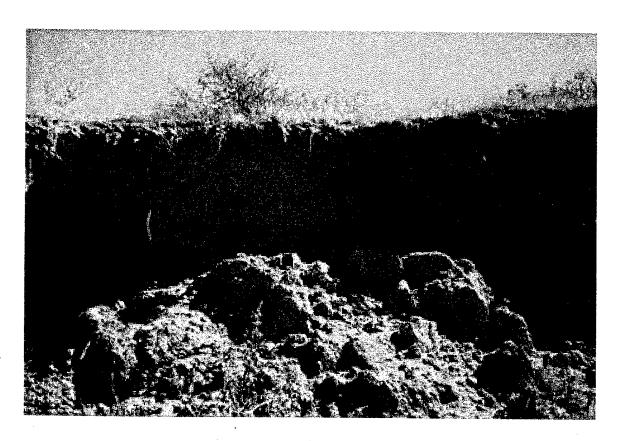
Figure 4.5

Slump debris at the side of a channel, PCMS. The remaining wall is essentially vertical, with a slight overhang induced by the root mat.

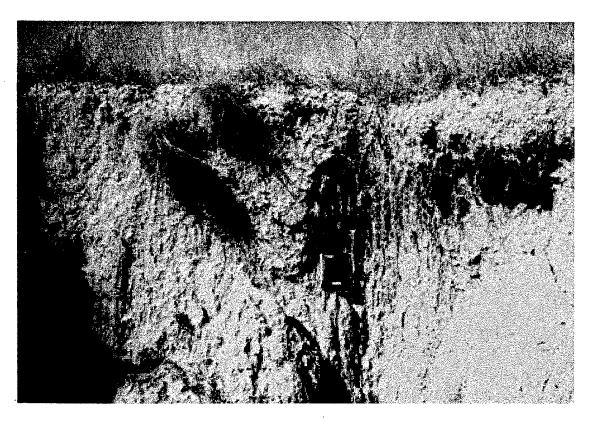
Figure 4.8

Vertical gully head being supported by a root mat, PCMS. Roots can be seen hanging from the bottom of the upper soil layer, which remains intact.

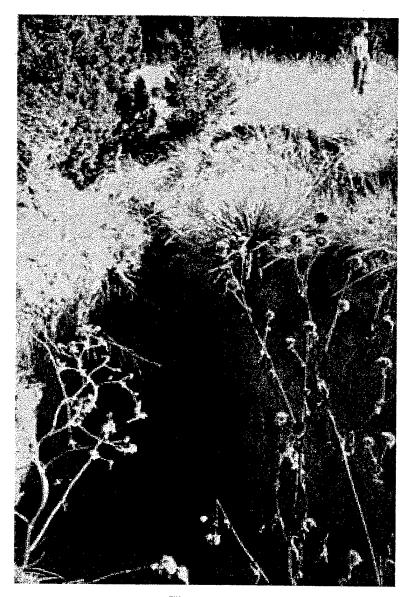
Figure 4.9

Gully head pinned by roots of the tree in the top-left of the image. Just below the tree, the 0.5 m deep, narrow channel drops 4.5 m to a rectangular gully. Tree roots were hanging from the soil below. Inside the gully the soils were damp. Despite the sizable drop, there was no obvious plunge pool at the base.
